MISCELLANEOUS PAPER GL-87-28

SUITABILITY OF SITES FOR HAZARDOUS WASTE DISPOSAL, CONCORD NAVAL WEAPONS STATION, CONCORD, CALIFORNIA

Final Report

Prepared for DEPARTMENT OF THE NAVY
Naval Facilities Engineering Command
Western Division
San Bruno, California 94066-0720

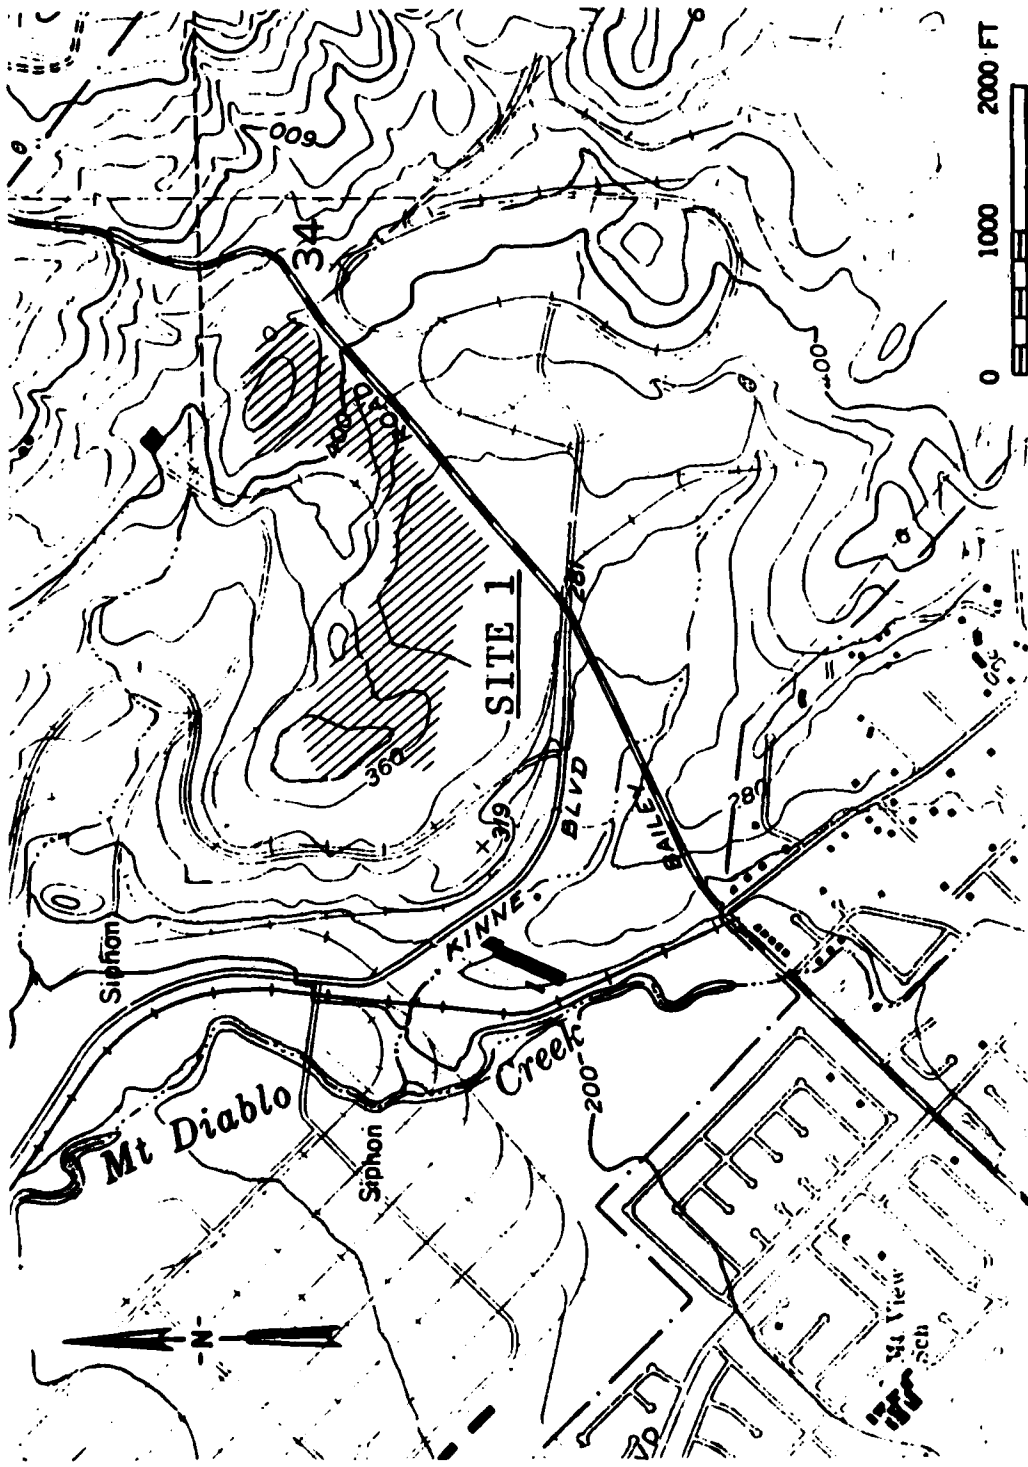
Figure 2. Site 1 and surroundings

24. The south half of Site 1 occupies low land along a short, unnamed tributary to Mount Diablo Creek. Because a branch of the Clayton fault apparently passes south of Site 1 (Figure 1), it is reasonable to presume that the rocky material found on the broad ridge continues into the low land beneath a veneer of Holocene alluvium.

25. Site 1 is unsuitable for a hazardous waste landfill primarily because the jointed sandstone and dacite and rubbly rock deposits observed at the site will have a high secondary permeability and will not meet the State criterion of low permeability. Subsurface testing was considered to be unnecessary to prove this deficiency, and Site 1 was dropped from further consideration.

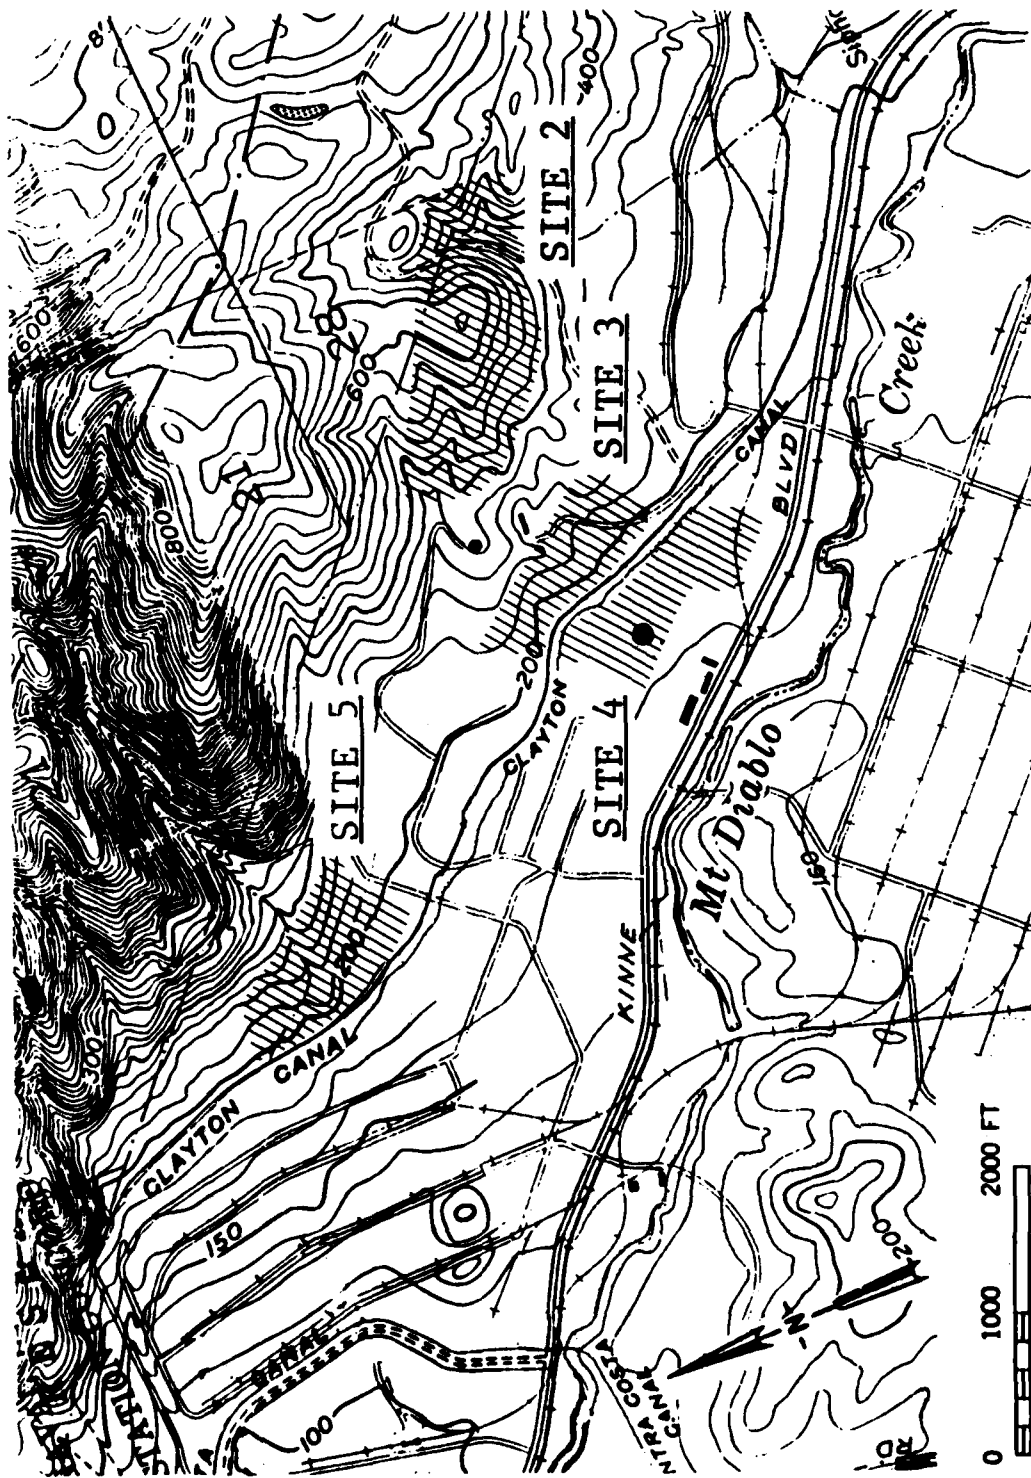
Figure 3. Sites 2, 3, 4, and 5 and location of drill hole (solid circle)

27. Site 2 is unsuitable for a hazardous waste disposal site primarily because the jointed nature of sandstone produces secondary permeability that can be expected to exceed the State's low-permeability criterion. The other major shortcoming of Site 2 is the steep terrain which will require extensive cut and fill and will be conducive to landsliding. The site was dropped from further consideration.

28. Site 3 lies in Section 28, T2N, R1W at the north side of Clayton Valley and adjacent to Los Medanos Hills (Figure 3). The area covers approximately 14 acres. The boundary between the Tertiary rock formations of the hills and the Holocene alluvium of the valley is the Clayton fault. The fault is classified by the California Division of Mines and Geology as inactive. The necessary 200-ft setback from the Clayton fault reduces the relatively small area of the site even further.

approximately 15 acres. The site appeared to satisfy criteria other than those concerned with protection of ground water and therefore was selected for subsurface investigation. The evaluation of Site 4 is presented in Part VI.

31. Site 5 is located in Section 21, T2N, R1W on the north side of Clayton Valley (Figure 3) upslope from Magazines 2AT76 and 2AT77. The area covers approximately 17 acres. The terrain has the configuration of an alluvial fan accumulated southwest of the mouth of a canyon in Los Medanos Hills. The alluvium was expected to be clay-rich like the Tertiary formations in the hills which made it promising as a site for hazardous waste landfiling.

32. In December 1986 water was found locally at and near the ground surface along the intermittent runoff channel from the source canyon. This channel crosses the center of Site 5 indicating that perched water rises to the surface at times during the year in violation of one of the State criteria against ground-water pollution. Because of this serious defect, Site 5 was rejected as undeserving of subsurface investigation and further consideration.

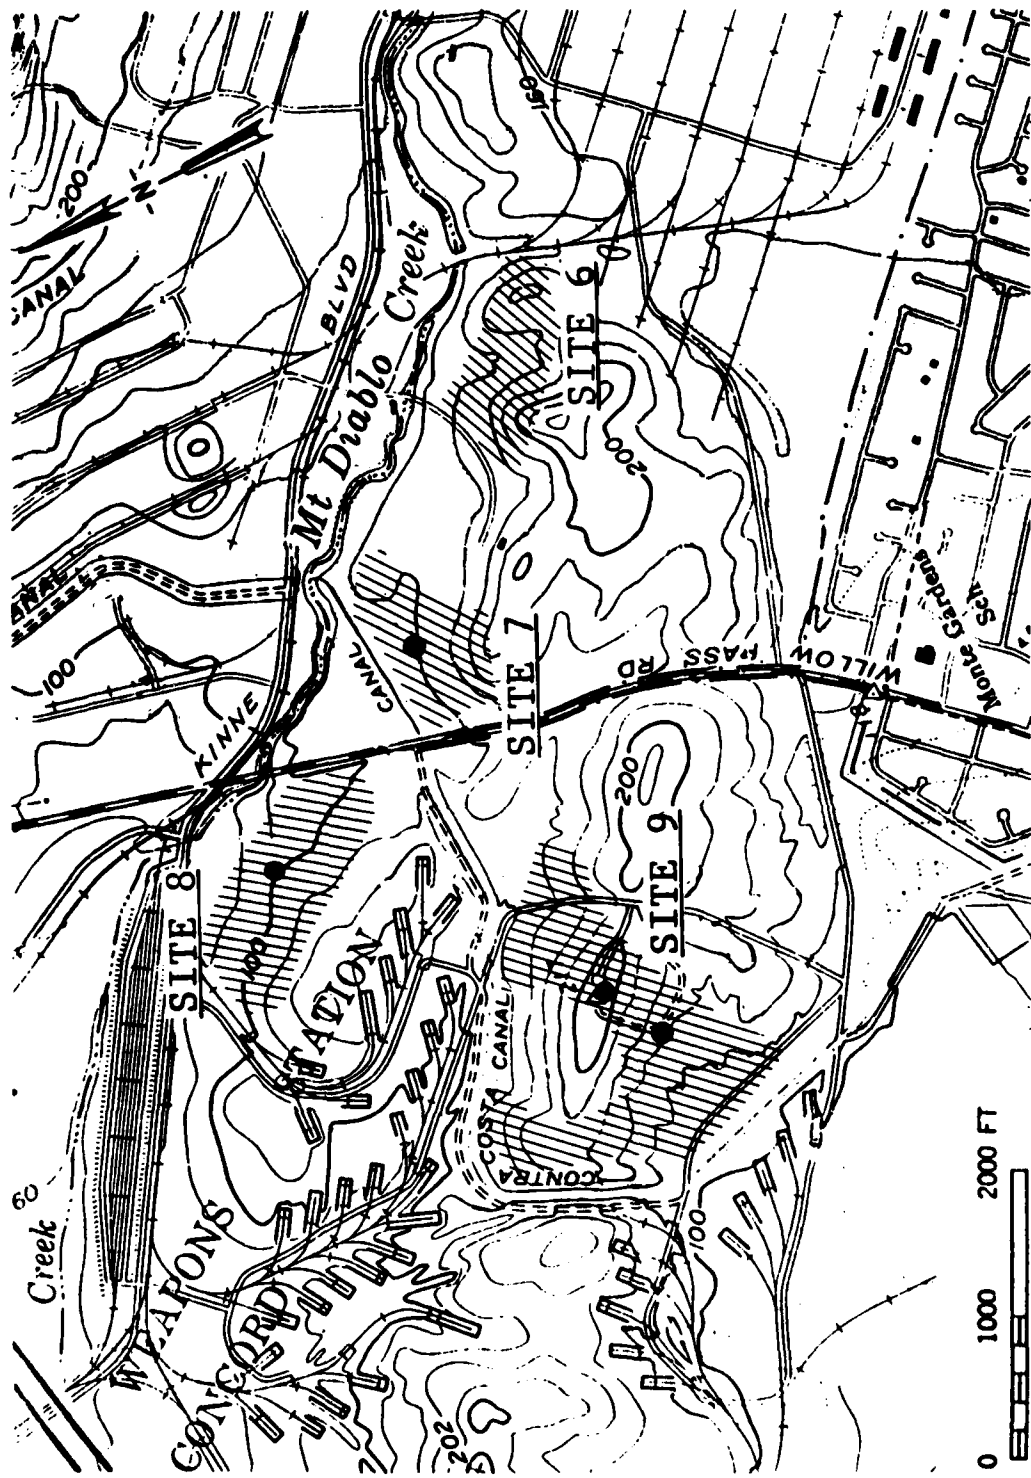
Figure 4. Sites 6, 7, 8, and 9 and locations of drill holes (solid circles)

33. Sites 6, 7, and 8 are 13-, 15-, and 26-acre areas, respectively, situated in Clayton Valley southwest of the floodplain of Mount Diablo Creek (Figure 4). In this position the soils at the three sites are expected to consist of a similar combination of Holocene alluvium related to Mount Diablo Creek over stiffer, older alluvium forming the broad hills further southwest. The Holocene alluvium presumably thins out completely near the southwest edge of the floodplain. The boundary between younger and older alluvium evidently passes through the sites but could not be pinpointed in the field.

34. Sites 6, 7, and 8 appeared to satisfy the criteria other than those concerned with protection of ground water. Two were investigated by drilling and sampling. Evaluations of Sites 7 and 8 are presented in Part VI. Site 6 was not drilled, but its subsurface is considered to be probably similar to that at Site 7.

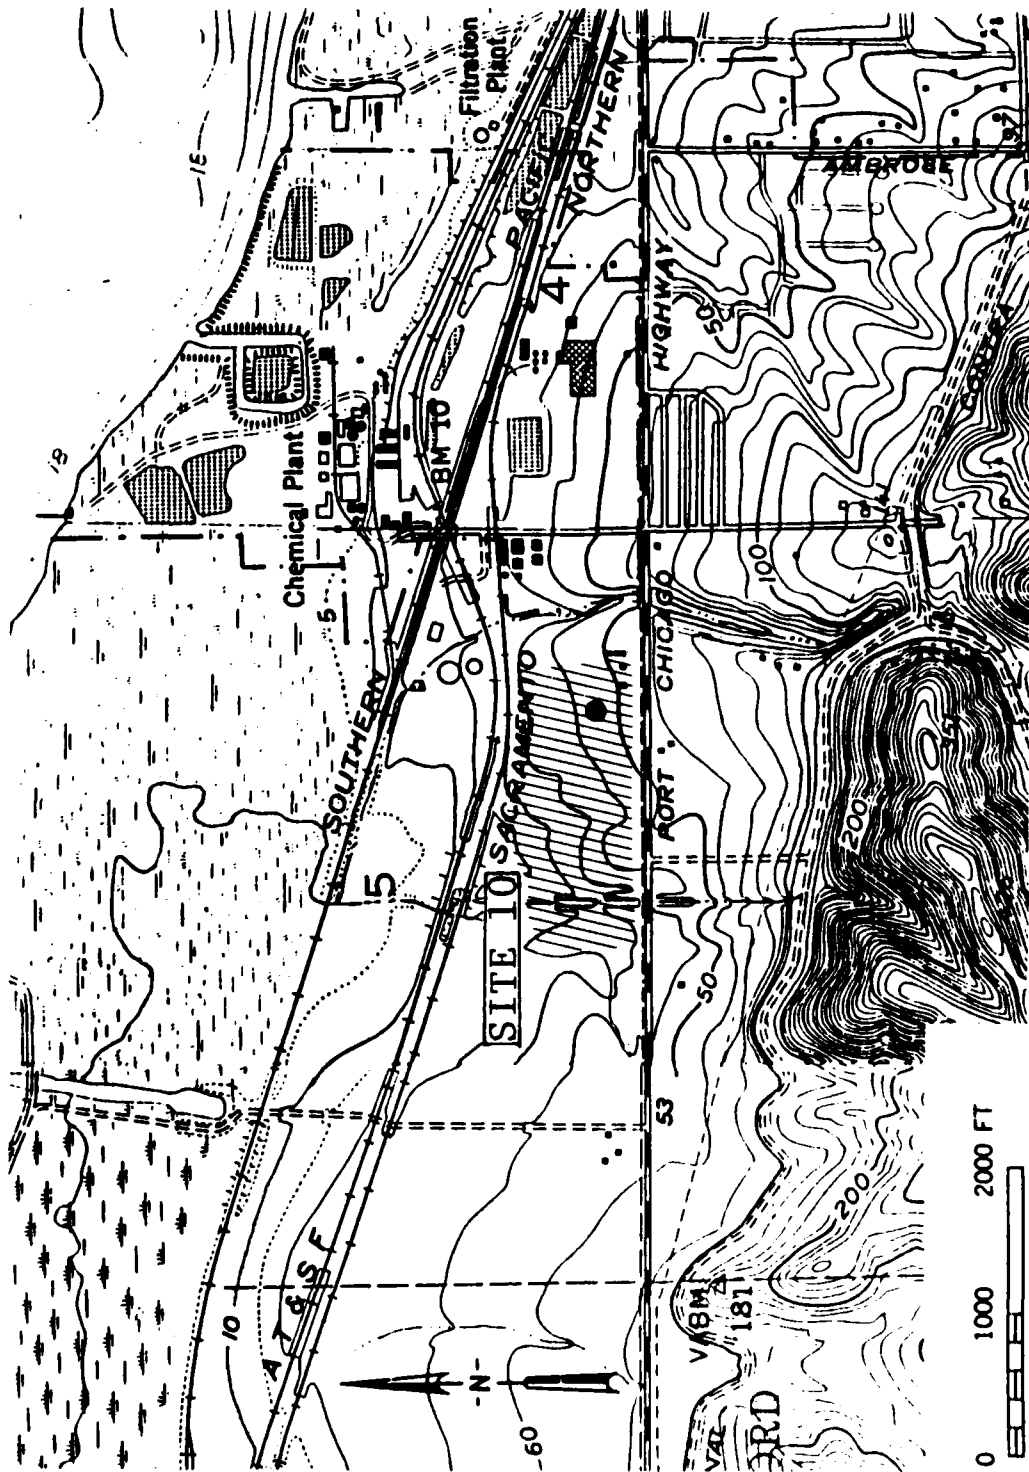
Figure 5. Site 10 and location of drill hole (solid circle)

36. Site 10 lies northwest of the intersection of Nichols Road and Port Chicago Highway in Section 5, T2N, R1W (Figure 5). The area is approximately 36 acres. The site is on a large alluvial fan located on the Pittsburg Plain and downslope from the mouth of a canyon from Los Medanos Hills. The narrow buffer of less than 1,000 ft along the east side is unfavorable and will need to be weighed in future evaluations against favorable features, location, and subsurface conditions as discussed in Part VI.

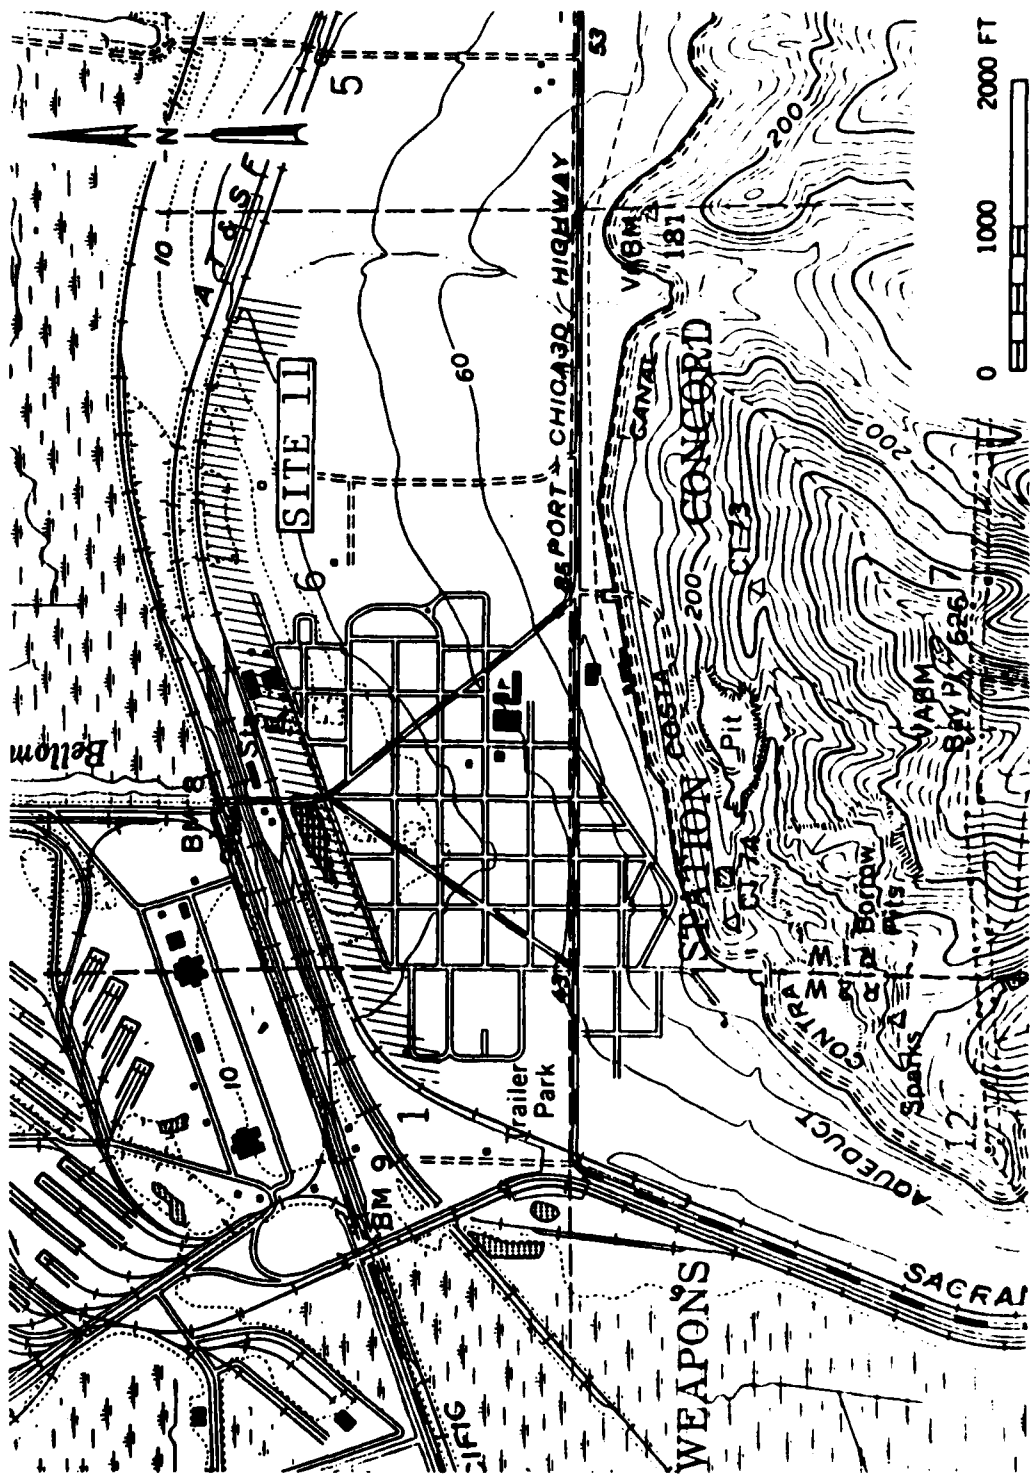
Figure 6. Site II and surroundings

37. Site 11 is located 0.3 miles north of the Coast Guard station north of Port Chicago Highway in Section 6, T2N, R1W (Figure 6). The area is approximately 40 acres. The site is narrow but extends about 1 mile east-west just south of the railroad right-of-way. The site is at the lower edge of the Pittsburg Plain. Ground surface is within about 10 ft of the level of Suisun Bay, and the presence of marshy ponds confirms a high-standing water table. The high water table makes this site unsuitable, and thus the site was not given further consideration.

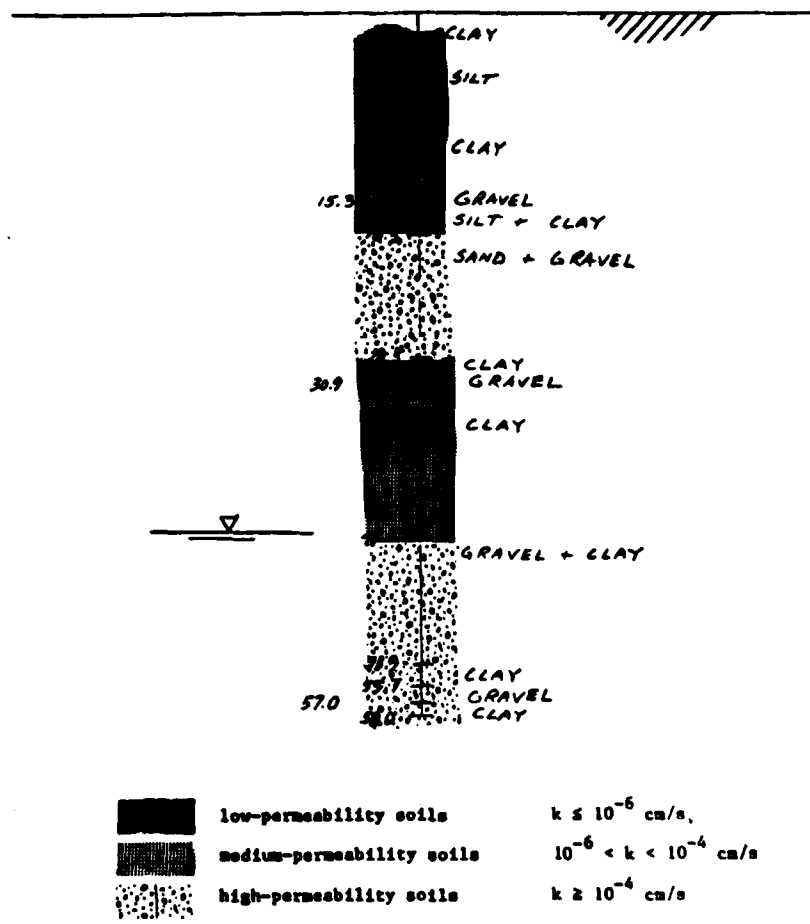
Figure 11. Generalization of Site 4 at drill-hole location

found with k value close to satisfying the pertinent State criterion (PART II), i.e. $k \leq 10^{-7}$ cm/sec. This layer at 28.5 to 30.2 ft is represented by sample No. 4 in Table 4. The top 4 ft of gumbo soil at the site was not tested but probably satisfies the State criterion also, except for root holes.

71. Low-density, well-sorted, granular soils were not found among samples within 50 ft of the surface, but such material presenting a potential for liquefaction during earthquake shaking may possibly remain hidden in the unsamples granular interval between 18 and 28 ft. The Clayton fault passes about 500 ft from the nearest side of the site, not close enough to violate the State criterion on Holocene faults.

72. Landslides are not a threat on the relatively flat valley floor. The site is not in the track of any reasonably hypothetical mudflow from Los Medanos Hills. The usual foundation settlements that would occur during the period when waste is disposed can be accommodated easily within design and

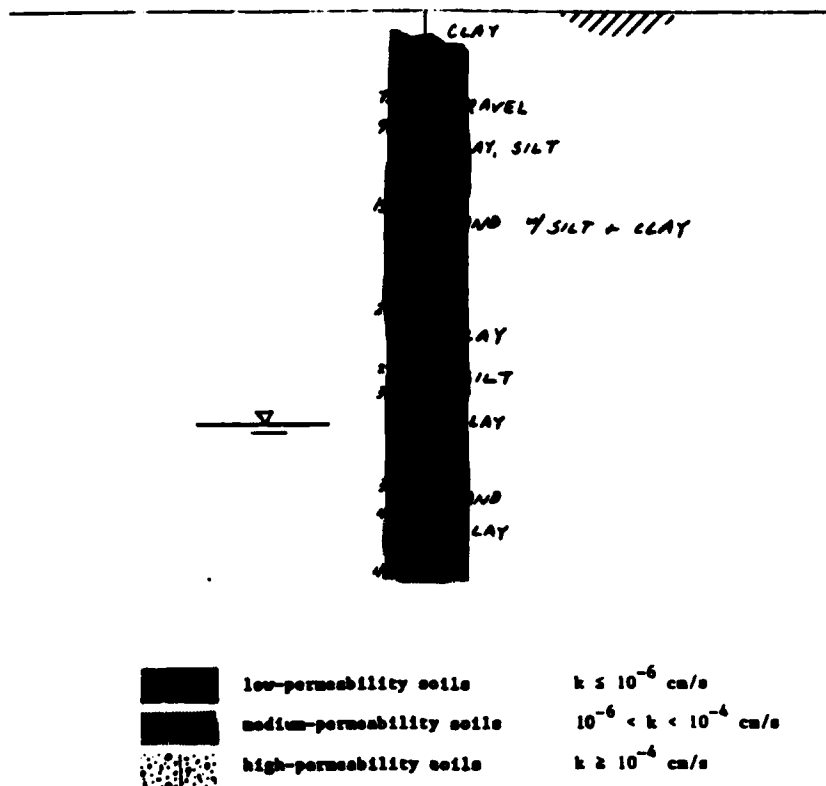
Figure 15. Generalization of Site 7 at drill-hole location

for liquefaction during earthquake shaking. It should be recognized however, that core recovery was poor at depth 19 to 25 ft (Figure 14), and susceptible beds might conceivably be present but undetected. This remote possibility should be pursued in the future if this site is selected for further investigations. Landsliding is unlikely on the relatively gentle valley floor. The low position of the water table also disfavors liquefaction and landsliding. Settlements would occur as the waste is disposed on the site material but would be relatively minor and can be accommodated in design and construction of such a facility.

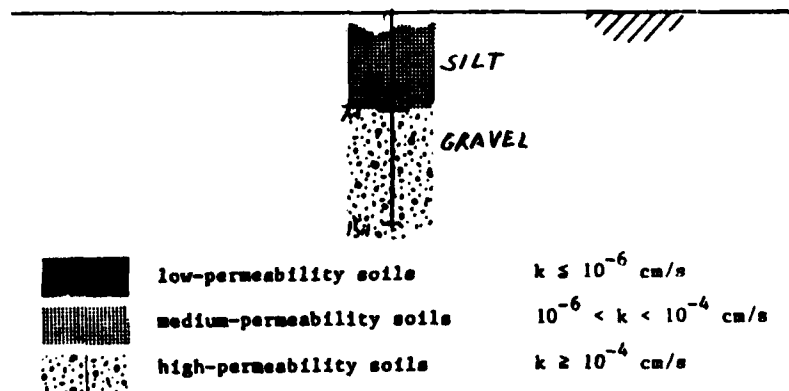
Figure 16. Generalization of Site 8 at drill-hole location

79. One hole was drilled at Site 8 and passed through clayey silt near the surface and entered a gravelly layer at about 7 ft. The gravel was loose and could not be sampled. Drilling was stopped at 15 ft. Drilling did not reach the water table. No testing was undertaken since the soils were considered too permeable and unsuitable as site media for waste disposal. Figure 16 is a profile of Site 8 at the drill-hole location as far as it was

explored. Conceivably, suitable strata might be encountered elsewhere on site, particularly upslope to the southwest.

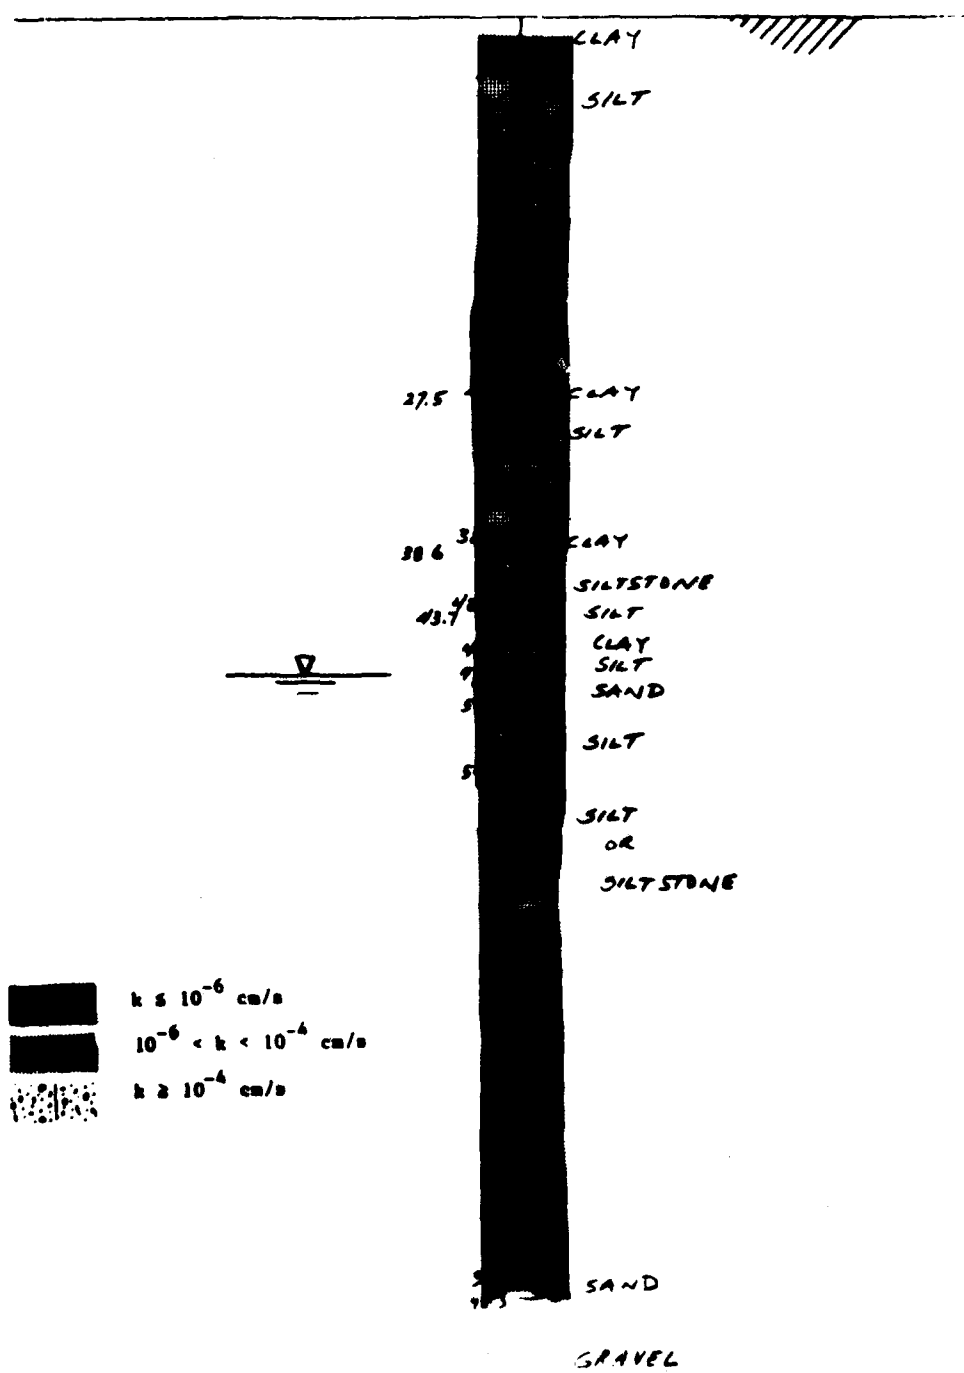
Figure 18. Generalization of Site 9 at final drill-hole location

85. Another manifestation of the apparently greater age of alluvium at Site 9 was a noticeable presence of hairline cracks in core samples. Some cracks appeared soon after extrusion from the sampling tube as though freed from heavy confinement of past overconsolidation. Some cracks were slicken-sided. The potentially detrimental effect of cracks on permeability of the soil media was demonstrated in the laboratory testing. Sample No. 5 had to be subjected to confining pressure substantially exceeding that equivalent to the field overburden to close cracks that had opened during specimen preparation (Figure 20). The k values decreased fivefold to 1.66×10^{-5} cm/sec as cell pressure was increased to 3 tsf.

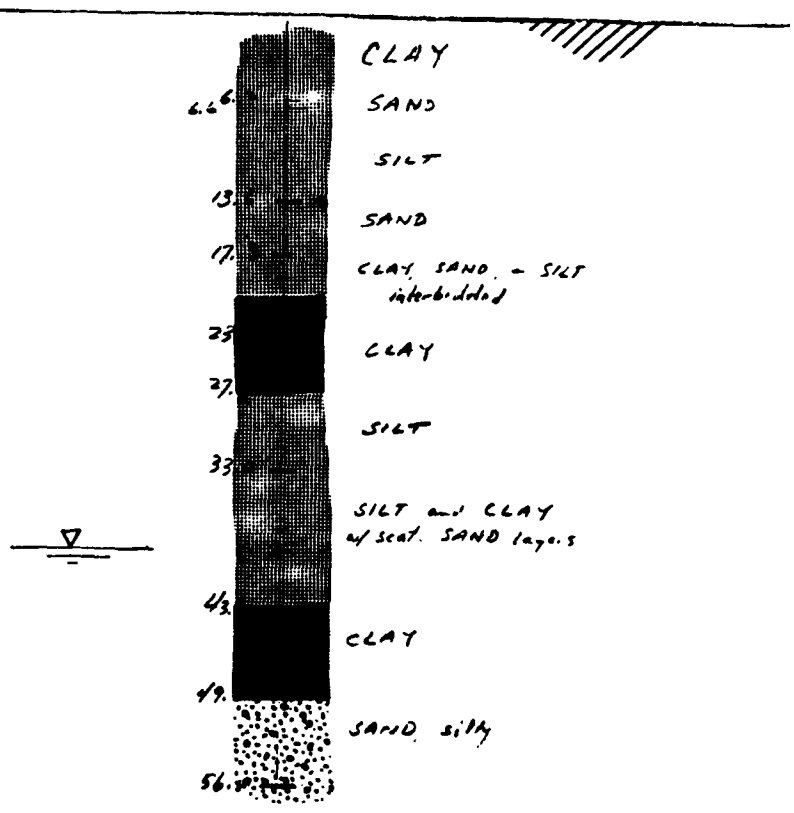
Figure 22. Generalization of Site 10 at drill-hole location

64 percent of medium-permeability, and 12 percent of high-permeability. Only one layer among those tested met the State criterion of $k \leq 10^{-7}$ cm/sec. A second layer was close. These layers are represented by samples No. 10 and 17 in Table 4.
